## Chapter 6 Study Guide and Case Studies: Earthquake Hazards

#### **Case Studies**

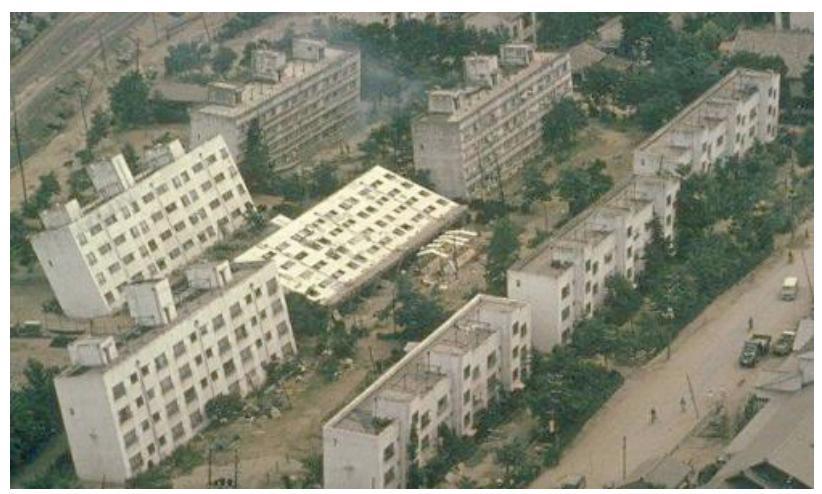
**Figure 6.C1** Liquefaction from the 16 June 1964 Niigata, Japan earthquake. Intact multi-story apartment buildings toppled over on liquefying ground. (source: Wikipedia)

Liquefying ground - The  $M_W$ = 7.6 16 June 1964 Niigata, Japan earthquake (Figure 6.C1) caused liquefaction over large parts of the city. The quake destroyed over 3500 houses and 11,000 were damaged. Most of the city is built on deposits from the Shinano and Agano river. These deposits have not yet consolidated to hard rock. By the time of the earthquake, Japan already built reinforced concrete buildings that can withstand earthquake shaking, such as happened during the Niigata earthquake. But the buildings toppled over, mostly intake, because the ground beneath liquefied. Similar buildings founded on piles reaching a firm layer at 20 m depth did not suffer damage. This earthquake also caused a 6m-high tsunami and 36 casualties. The first wave from the tsunami hit the city 15 min after the shaking. The first wave was the highest in many places but the third one was highest in other places.

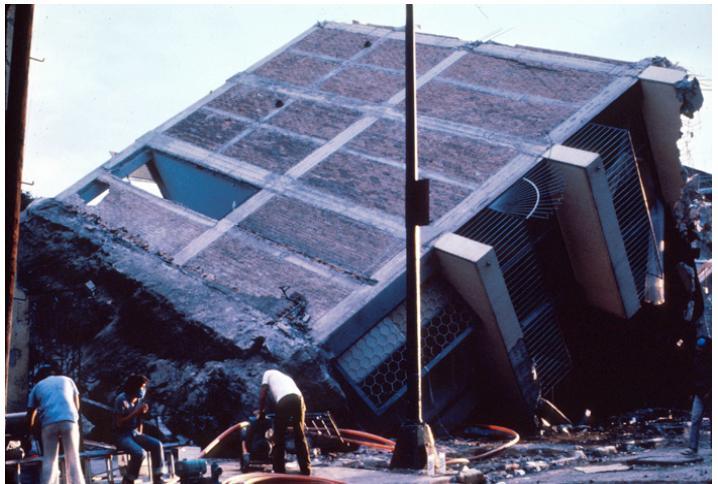
**Figure 6.C2** Damage from the 19 September 1985 Mexico City earthquake. An eight-story structure with brick infill walls broken in two. The foundation also came off. (source: M. Celebi, USGS)

Liquefying ground - The  $M_W$ =8.0 19 September 1985 Mexico City earthquake (Figure 6.C2) caused violent shaking in the city (intensity IX on the Mercalli scale) even though the epicenter was 350 km away, off-shore. The quake killed between 5,000 and 40,000 people (number somewhat uncertain) and injured tens of thousands more. 412 buildings collapsed and 3124 more were damaged.

The city experienced so much shaking and destruction not lastly because the city is built on an ancient lake bed where the water-bearing volcanic sediments have not yet consolidated to hard rock. The city is therefore vulnerable to extensive liquefaction. A survey by the government found that few of the 1-5 story buildings and buildings taller than 15 stories were seriously damage. The lake bed resonates with seismic waves at certain periods (around 2.5 s) that also cause certain 6-15-story buildings to resonate and ultimately collapse.

Drawing from experience of earlier large earthquake (1957, 1979) Mexico city had a building code in place. But the intensity of the shaking during 1985 earthquake was larger than previously experienced. One remarkable survivor building was the 44-story Torre Latinoamericana. It was constructed with two hundred piles extending down over into the stable layer 30 m below the surface.

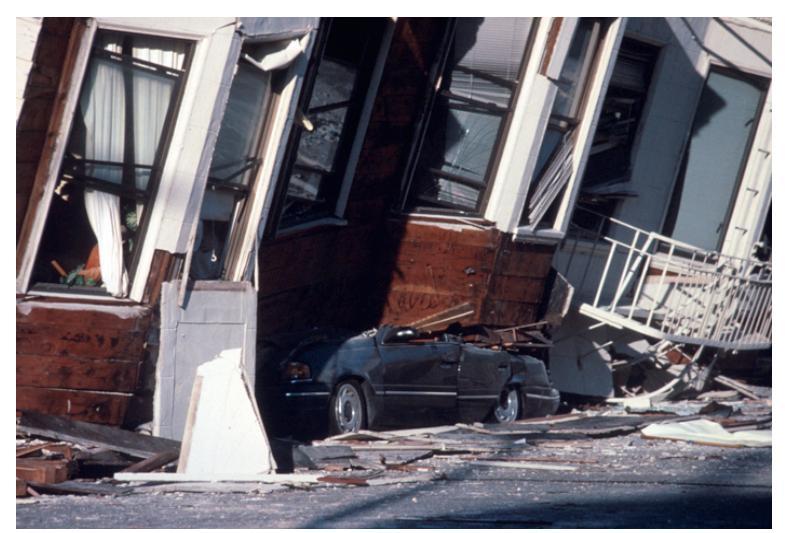
**Figure 6.C3** The 17 October 1989 Loma Prieta Earthquake earthquake caused widespread liquefaction in the Marina District in San Francisco. Left: an automobile lies crushed under the third story of this apartment building. The ground levels are no longer visible because of structural failure and sinking due to liquefaction. (source: USGS)

**Liquefying ground - The M<sub>W</sub>=6.9 17 October 1989 Loma Prieta Earthquake** was an oblique strike-slip earthquake on the San Andreas Fault and about 70 km south of San Francisco. The quake caused an estimated \$6 billion in damage. It caused severe damage in San Francisco's Marina District and in Oakland as a result of liquefaction (Figures 6.C4, 6.C5). Other effects included sand volcanoes and landslides. The Marina District was built on a landfill made of a mixture of sand, dirt, rubble, waste and other materials containing a high amount of ground water. Some of the rubble came from clean-up after then 1906 earthquake but most came from debris laid down for the 1915 Panama-Pacific International Exposition. Seven buildings collapsed and four were destroyed by fire. The buildings that collapsed where older so-called 'soft story buildings' with ground floor garages. The fire was caused by a ruptured gas main, similar to the 1906 earthquake. Another 63 building were found to be too dangerous to live in.

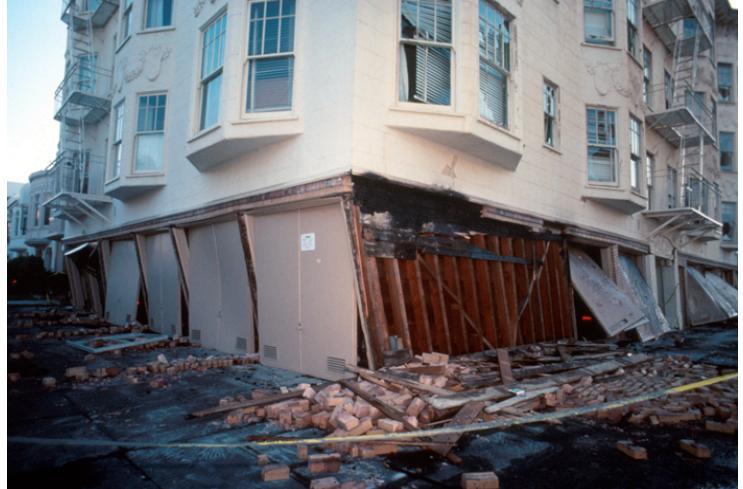
**Figure 6.C4** Another building in the Marina District that was severely damage by the 1989 Loma Prieta earthquake. The lack of adequate shear walls on the garage level exacerbated the damage. (source: USGS)

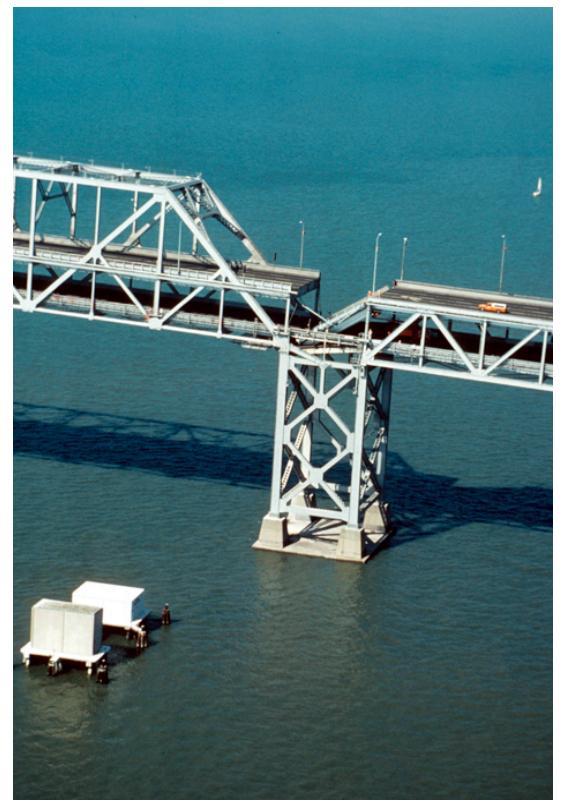
**Figure 6.C5** Roadbed collapse on the San Francisco-Oakland Bay Bridge caused by the 17 October 1989 Loma Prieta Earthquake, and one fatality. The bridge was reopened only a month later. (source: USGS)

A total of 63 lives were lost. The Cypress Viaduct of Interstate 880 in Oakland collapsed, killing 42 people. Some parts of the San Francisco - Oakland Bay Bridge also collapsed (Fig. 6.C5). Because the quake occurred during a national live broadcast of the 1989 World Series, rush-hour traffic on the Bay Area freeways was lighter than normal which prevented a larger loss of lives. An estimated 1.4 million people lost power as a result of damaged electrical substations.

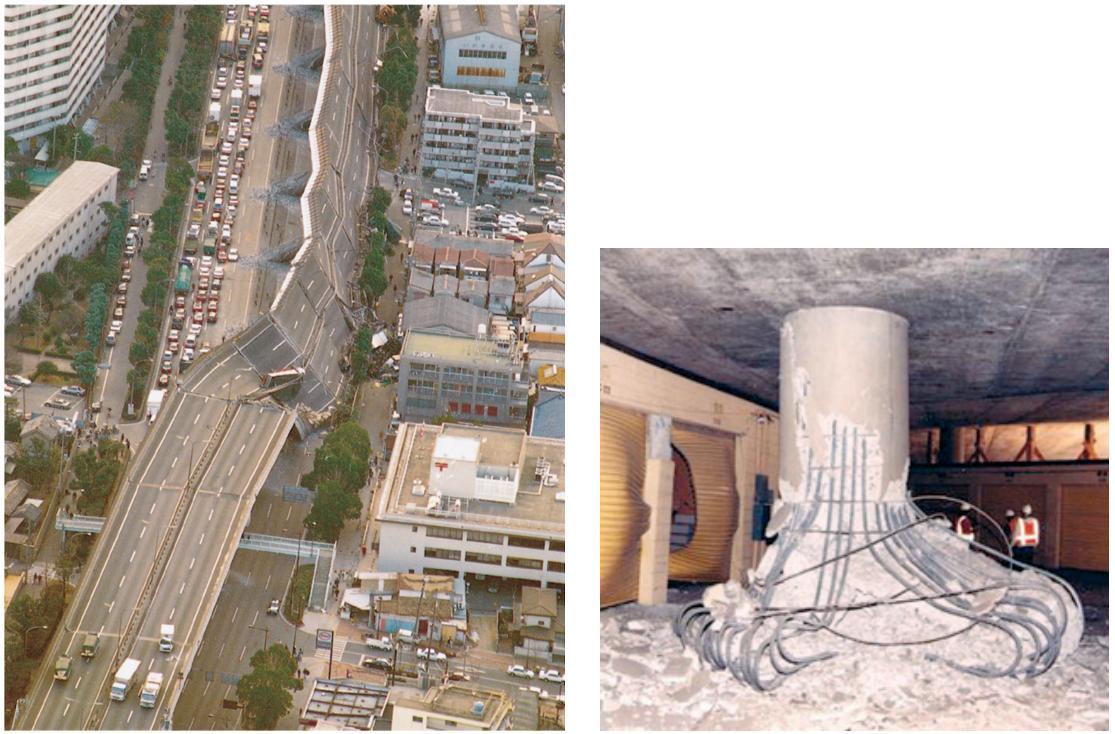
**Figure 6.C6** Left: An expressway collapsed during the 17 January 1995 Kobe, Japan earthquake. Right: Retrofitted support columns of many freeways in southern California withstood the 1994 Northridge earthquake, while non-retrofitted failed. (source: ME and USGS)

Liquefying ground - The  $M_W$ =6.8 17 January 1995 (Great Hanshin) Kobe, Japan earthquake (Figure 6.C6) caused widespread liquefaction on Awaji Island, killing 6434 people (4600 in Kobe) and leaving 300,000 homeless, and causing \$102 billion in damage. This was Japan's worst earthquake in the 20<sup>th</sup> century after the Great Kanto earthquake in 1923 that claimed 105,000 lives. Although located in a subduction zone, this earthquake was a strike-slip earthquake, with many aftershocks.

Damage was extremely widespread and severe. On the order of 400,000 buildings were damaged beyond repair. Numerous elevated road and rail bridges, and 120 of the 150 quays in the port of Kobe were destroyed. Images of the collapsed elevated Hanshin Expressway made front page news around the world. Artificial islands in Kobe suffered subsidence caused by liquefaction, where water reached the surface. The quake triggered around 300 fires, disrupted water, electricity and gas supplies.

This quake was a major wake-up call for Japan's disaster prevention authorities. Most people though that the steel-reinforced concrete expressways were safe. While later inspection revealed that most structures were constructed properly. But building codes

had changed over time and only new constructions were built to the latest code. Subsequently, buildings were placed further apart to avoid a falling-domino effect and rubber shock absorbers were installed under bridges.

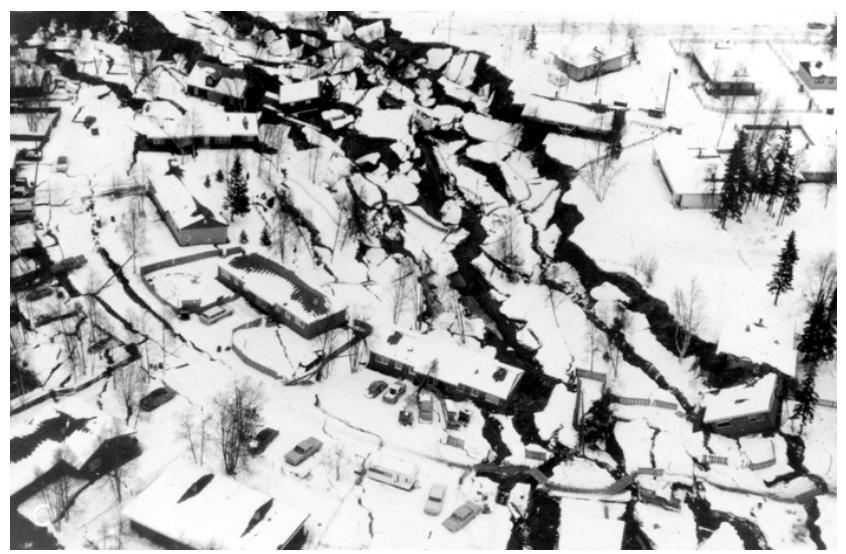
**Figure 6.C7** Liquefaction destroyed a neighborhood in Turnagain Heights, Alaska after the "Good Friday" 27 March 1964 earthquake. (source: USGS)

Liquefaction of a subsurface layer, tsunami - The  $M_W$ = 9.2 27 March 1964 "Good Friday" Alaska earthquake (Figure 6.C7) caused widespread liquefaction. The quake lasted over 4.5 minutes and remains the most powerful earthquake recorded in North American history. The megathrust earthquake ruptured 970 km along the fault, and the ground moved up to 18 m. It caused fissures, landslides, tsunami, and 131 people perished.

The quake also caused liquefaction. In Turnagain Heights, a large area failed when a weak and water-saturated subsurface clay layer liquefied and the strong layer above broke into pieces. Locally, the ground dropped by several meters.

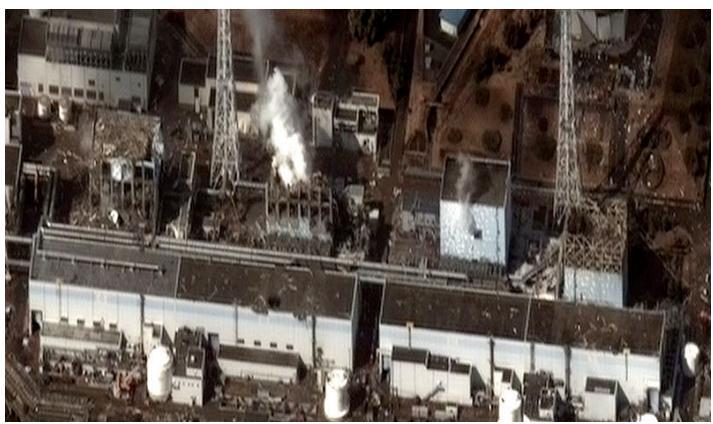
**Figure 6.C9** Destruction at the Fukushima, Japan power plant after the 11 March 2011 Tohoku earthquake and tsunami struck. (source:Wikipedia)

**Nuclear Meltdown - The Mw=9.1 11 March 2011 Tohoku Earthquake** (Figure 6.C9) was a tsunami-genic megathrust earthquake. It was the most powerful earthquake ever recorded in Japan. The tsunami reached heights of up to 40.5 m and traveled at 700 km/h up to 10 km inland in Sendai. Initial reports lamented 2000 fatalities, but this number was revised a few years later and now stands at nearly 16,000, with 2500 still missing. Most people died in the tsunami where residents of Sendai had only 8-10 minutes of warning.

The most shocking incident that caused the subsequent phase out of peaceful nuclear power generation in some European countries was the meltdown of the Fukushima-Daiichi nuclear power plant. While the plant and reactors withstood the shaking, the 14-m tsunami overtopped the 5.7-m seawall and caused flooding in the plant. The subsequent power outage caused failure of the cooling, and the nuclear reactors overheated. At least three reactors exploded within days after the earthquake, releasing

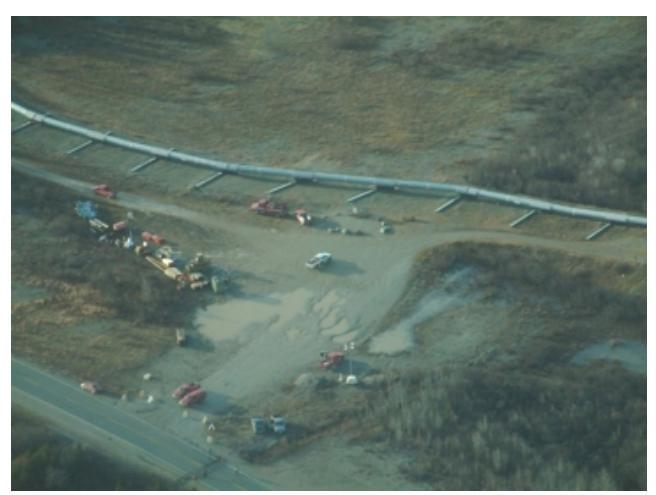
**Figure 6.C10** Arial photo of the Trans-Alaska Pipeline System (TAPS) near the Denali fault. Here, the pipeline is supported by rails on which it cane move freely in the events of fault offset. The pipeline moved during the 2002 earthquake but no break occurred. Note the break in the street near the bottom of the photo. (source: Division of Geological and Geophysical Surveys, Alaska State Department of Natural Resources)

On Nov 3, 2002 a large magnitude 7.9 earthquake occurred along the Denali fault, about 160km south of Fairbanks/Alaska. There have been smaller earthquakes in the past (e.g M 7.2 in 1912, M 6.2 in 1958). The predominantly right-lateral strike-slip event caused the surface to rupture for a total length of 320 km (Figs. 6.C10, 6.C11). The earthquake caused numerous debris flows, avalanches, snow slides and rock falls along the fault and significant horizontal displacement. For example, scientists measured an offset of 2.5 m on the Richardson Highway while a section of the Trans-Alaska Pipeline did not break. The pipeline is built above ground and sits on a frame. During transport the oil is to be kept warm to flow and burying the pipeline in permafrost would melt the ground and make it unstable. In areas prone to earthquake shaking, the pipeline's frames sit on rollers. The pipeline was designed to withstand magnitude 8 earthquakes and though the pipeline was shaken off its frame, it did not burst.

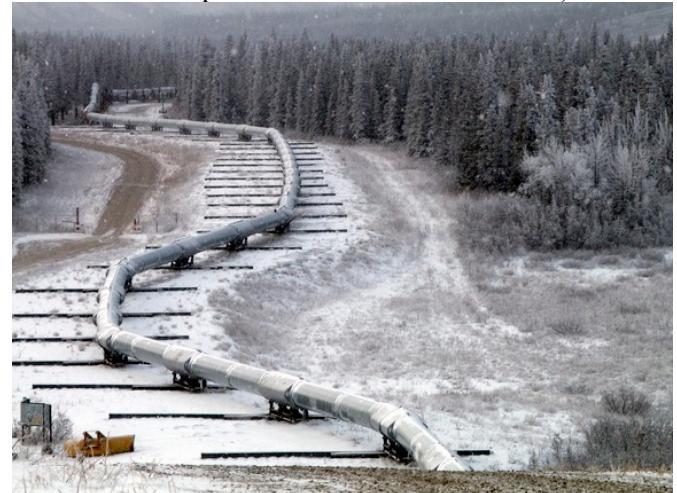
**Figure 6.C11** View along the TAPS in the zone where it was engineered for the Denali fault. (source: USGS)
